MX-1 SERVICE CHECKLIST

This checklist contains symptoms and cures for problems which are most frequently encountered on the model MX-1. The following information is provided to aid technicians in locating specific as well as intermittent problems. To avoid repeat service calls check all items listed when servicing this model for any reason.

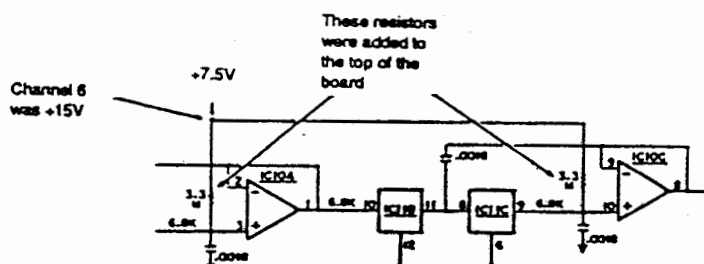
SYMPTOM: Intermittent pop in orch plus voices most noticeable on Blue Grass pattern.

CURE: Two 3.3M pullup resistors have been added to channel 3 (6) IC10 pins 3 & 10, and where attached to +15V. This wire should be removed and attached to 7.5v see diagram below.

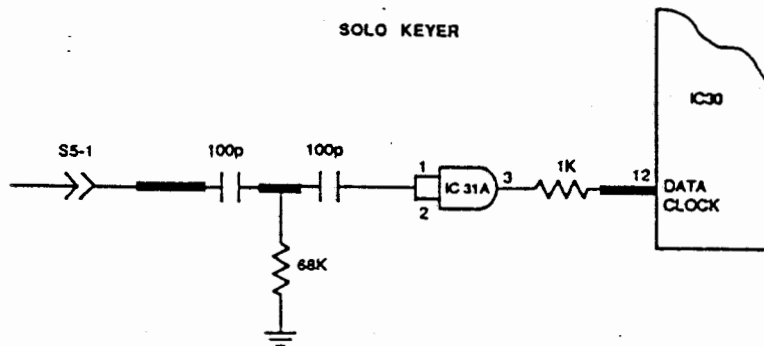
SYMPTOM: 1) Solo percussion voices rekey when held or
2) Solo brass voices have intermittent thump noise when held.

CURE: Make the following circuit changes to schematic 26 board 12.

- 1) Cut the copper track between S5 pin 1 and the 1K resistor located at pin 12 of IC 30 in 3 places.
- 2) Add 2 100P capacitors in series as shown below.
- 3) Connect a 68K resistor from the junction of 100P capacitors to ground at pin 31 of IC30.
- 4) Cut copper track that connects pin 1 & 2 of unused AN gate IC31A to ground.
- 5) Connect a wire from the open ended 100P capacitor to the pin 1 & 2 of IC31A.
- 6) Connect a wire from pin 3 of IC31A to open end of 1K resistor that connects to pin 12 of IC30.
